Road Construction in Soil Creep Areas

S. S. LIEW, S. S. GUE & C. J. WONG

G&P Geotechnics Sdn. Bhd., Malaysia

ABSTRACT: This paper presents a general view and framework of engineering construction over ground with characteristics of creeping deformation and addressing the driving forces and probable causations of such observed creeping deformation. The common problems or engineering implication arising from such creeping deformation to linear infrastructure development will be discussed from the aspects of design, construction and maintenance. Strategy and possible engineering solutions for each nature of the creeping deformation are summarised. Ten interesting case histories with creep movement will be briefly presented to illustrate the investigative findings.

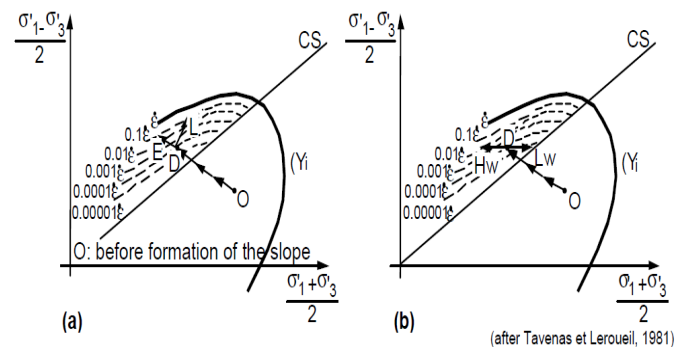
Figure 10: Schematic creep effects and effective stress conditions in natural slopes (a) For loading at the crest (DL) and erosion at the toe (DE), (b) for pore pressure fluctuations,

**DHW and DLW (Tavenas and Leroueil, 1981
 Leroueil et al 1996)**

(a) Creep deformation exists within all soil elements regardless of any levels of deviatoric stress. The stress conditions of soil elements within a “perfectly” stable slope are always in the over-consolidated domain, i.e. within the yield surface of the t-s stress plot. Figure 10 shows schematically the stress conditions in a saturated slope. The state of stress for a stable soil element can be represented by a point such as D in Figures 10a and 10b. If the slope is subjected to either loading at the crest or erosion or excavation at the toe (stress relief condition), the stress conditions move respectively to L or E on Figure 10a. As the groundwater regime in the slope varies seasonally, the stress conditions move in Lw direction corresponding to low water conditions or in Hw direction when high water conditions prevail (Figure 10(b)). Creep rates also vary with the seasons, being much higher when water conditions are high.

Local failure as initiated when the stress state, either E on Figure 10(a), or Hw on Figure 10(b), reaches the peak strength envelope corresponding to the age or the strain rate of the slope. After surpassing the peak strength, stress conditions progressively move towards the critical state (CS) line, and the unbalanced shear stress of the stressed soil element being limited to the critical state strength (lower than the peak strength) is transferred to the neighbouring soil elements, in which the local failure would be progressively extended to. This phenomenon of progressive failure can extend into a continuous development of shear surface through the entire soil mass, and then trigger a landslide when the ruptured shear surface extends throughout the entire soil mass.
